Global Journal of Arts Education

Volume 11, Issue 1, (2021) 102-116

Loss of identity in buildings of modern architecture; The case of Edirne government house

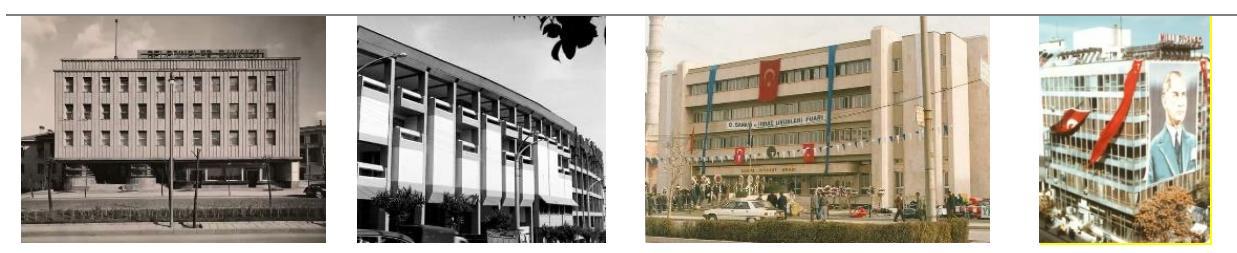
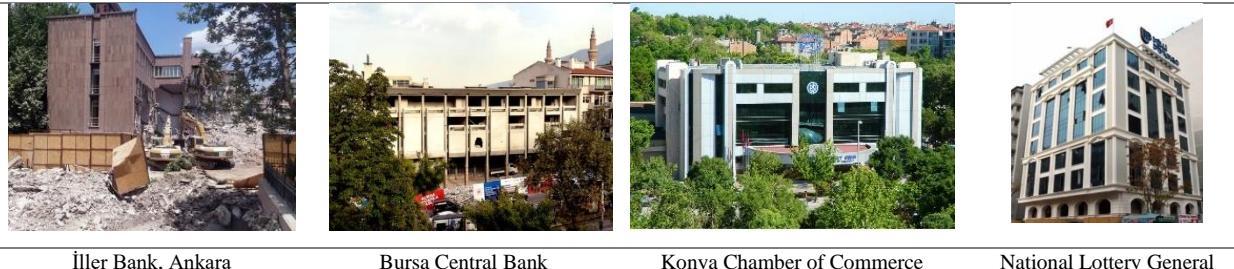
Table 1. Modern Architecture buildings in Turkey that have been demolished / changed facades in recent years

demolished in 2017 (Arkiv, 2021: Mimarizm, 2021)

Bursa Central Bank demolished in 2020 (Mimdap, 2021) Konya Chamber of Commerce changed facades in 2004

changed facades in 2004 (Mimormimarlık, 2021: Aproje, 2019) National Lottery General Directorate Building

changed facades in 2013 (Yürük, 2020)

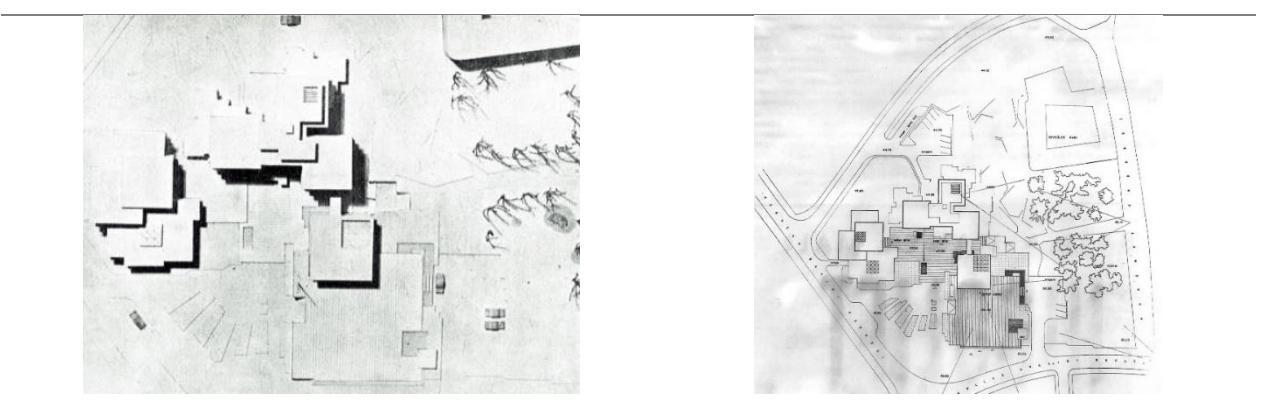
Table 2. Identity of contest project

The design was created in fragmented masses that respected the historical pattern in terms of templates and relevant scales. Use of concrete, a modern construction material, in the project as well as modern materials and suitable colors helped the process of adaptation to the general expression regarding the historical area. The facade characteristics contained simple and clear lines and reflected the contemporary architecture of the era. Vertical bands of the facades, use of modern materials, geometric and fragmented masses free from adornment, terrace roofs, and entrance of Governor's Office with columns bear the traces of Early Modern Architecture Period (Table 2).

Model of the contest project and site plan (Edirne Governmental Office Building Architectural Project Contest (1965).

Edirne Government's Office was constructed within the "Modern Architecture" trend considering the period it was built (Table 2). As a work of Modern Architecture, this building contained the social values, and values of being canonical and referential, which are among the assessment criteria (Docomomo, 2020) (technological values, social values, artistic and aesthetic values, being canonical and referential, and values related to integrity) that would be used in documenting the international Modern Architecture heritage in 1993 of DOCOMOMO International², and above all, the building had a "documentation-based value". The buildings of 20th century are as valuable as the buildings of the previous centuries, and they are among the buildings to be conserved. As these buildings have a place within the urban memory, they also constitute a part of our culture and are among the examples that will direct our future; therefore they should be conserved. For Edirne Government House, a maintenance and restoration project was assigned through bidding to a private company by the Directorate of Support Services at Edirne Provincial Special Administration in 2015. This maintenance and restoration work was not considered a part of a restoration project and supervised by the Cultural and Natural Heritage Conservation Board as Edirne Government House was not defined and registered as a cultural asset. Having been completed in a period as short as 45 days, this maintenance and restoration work was conducted by emulating the mansions in the area of government house, which caused the project to deviate from the original design and traces of the past to be misrepresented as the historical monuments were copied. The entrance of the Governor's Office that was constructed during this restoration was painted in green first (Figure 10) and then in earth color following another restoration.

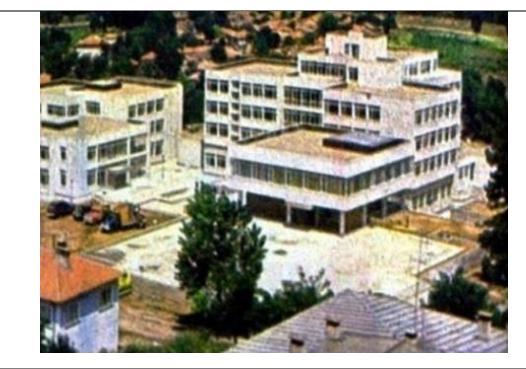
Form of the building during when it was constructed (Arkitera, 2020)

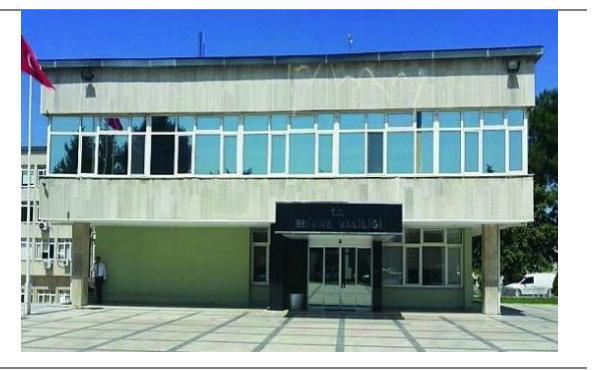
The entrance to the governorship before the renovation (Edirnehaberci, 2020)
